Fire Towers, Lumber, and Corrosion - Should We Be Concerned?

Ed Engelman, December 3, 2020
engelman.ed@gmail.com

The Rock Rift Fire Observation Tower is located on Tower Mountain above the Cannonsville Reservoir in the Town of Tompkins, Delaware County, New York. This investigation will inform decisions to be made regarding its restoration.

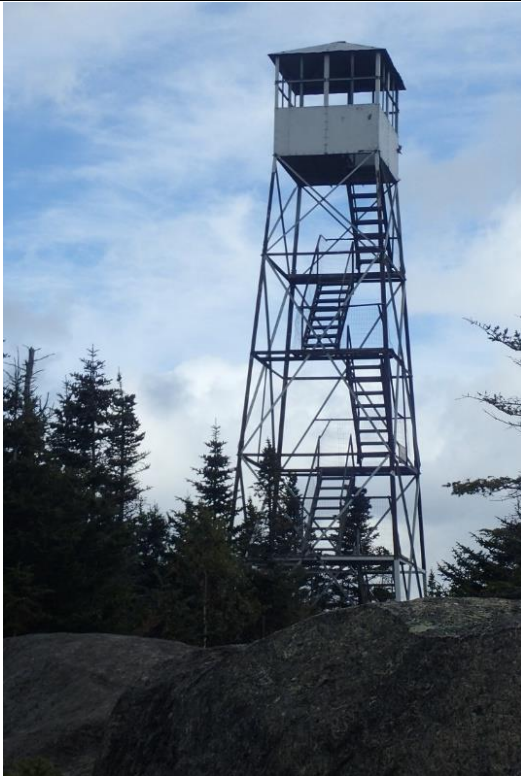
Pieces of the 100-year-old cross braces from the St. Regis Fire Tower were used in this investigation. The old braces were replaced by the Friends of St. Regis Fire Tower with newly manufactured hot dipped galvanized braces in 2018 and 2019

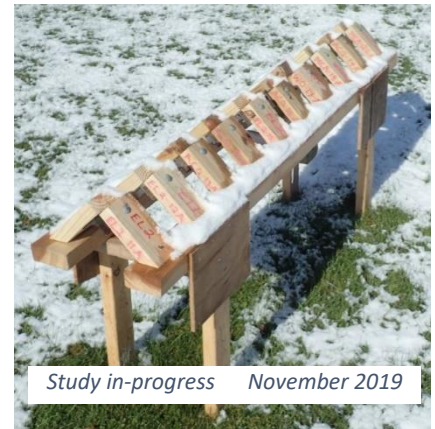
The steel that was in direct contact with white oak lumber rusted. This was readily evident on each sample. White oak lumber is quite acidic, and this result was not unexpected. The samples with the Grace® water and ice shield and the Rust-oleum® painted barrier did not show any rusting.

White oak lumber has several excellent qualities. It is strong, decay resistant, and a local woods product. This study shows that if white oak is attached to a galvanized steel surface that a barrier is needed to minimize corrosion. The ice and water shield is quick and easy to apply and does not require the drying time of a paint. The Grace® Ice and Water Shield stood up to removal of the lumber and maintained its integrity. The Rust-oleum® 5200 System DTM Acrylic paint also protected the steel. Portions of the paint pulled away from the steel upon disassembly.

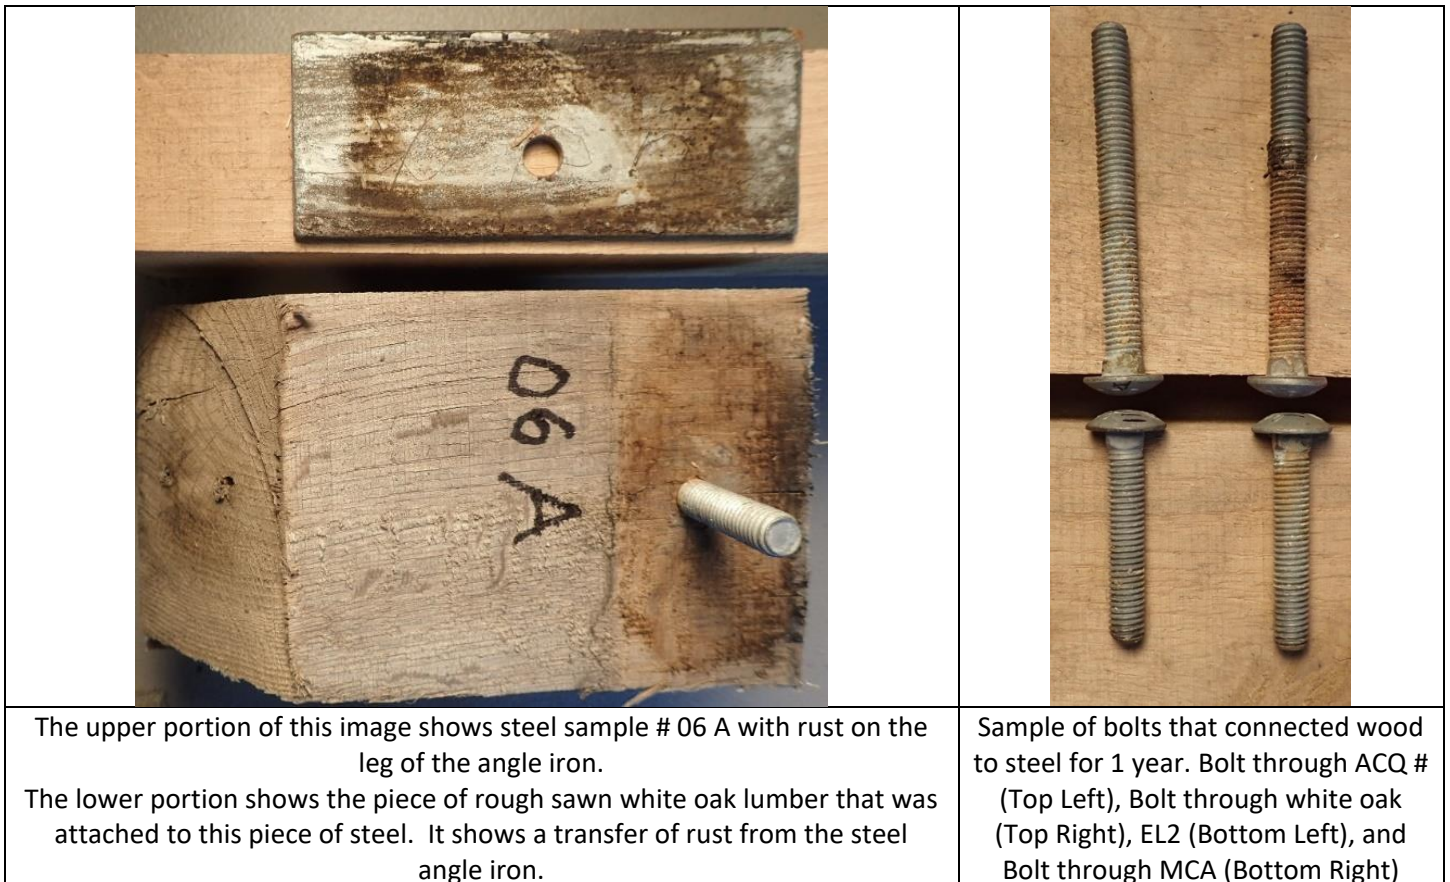
The bolts through the white oak lumber showed the most corrosion (WO). Moderate corrosion is seen along the threads of the bolts from the Alkaline Copper Quaternary (ACQ) pressure treated lumber samples. Light corrosion is seen along the bolts that were imbedded in the Micronized Copper Azole (MCA) pressure treated lumber. MCA lumber was developed to be less corrosive than ACQ. This demonstration supports that claim. Of the four lumbers used the MCA formulation used in this investigation is the only one recommended for ground contact. The others are only for non-contact or above ground use. Corrosion is not evident on the bolts in the Ecolife II treated lumber (EL2).

Perhaps the corrosion of the bolts in the white oak, ACQ, and MCA lumber is acceptable. Bolts can be viewed as an acceptable sacrifice as compared to the cleats of the stairs or the angle iron supporting the landings. Bolts can be replaced more easily than the steel structure of the fire tower.

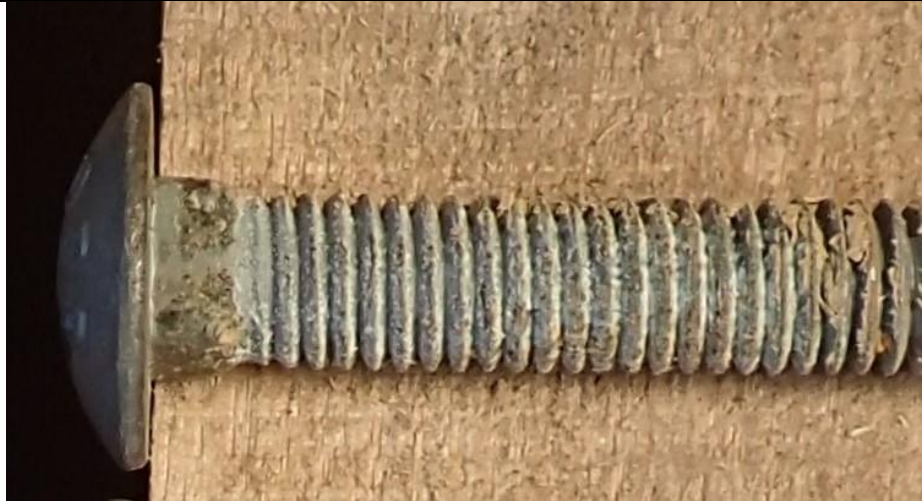
<p>The bolt on the left was imbedded in ACQ lumber. In addition to surface corrosion this close-up image shows pitting on the crest of the thread and along the thicker flank portion of the thread.</p>

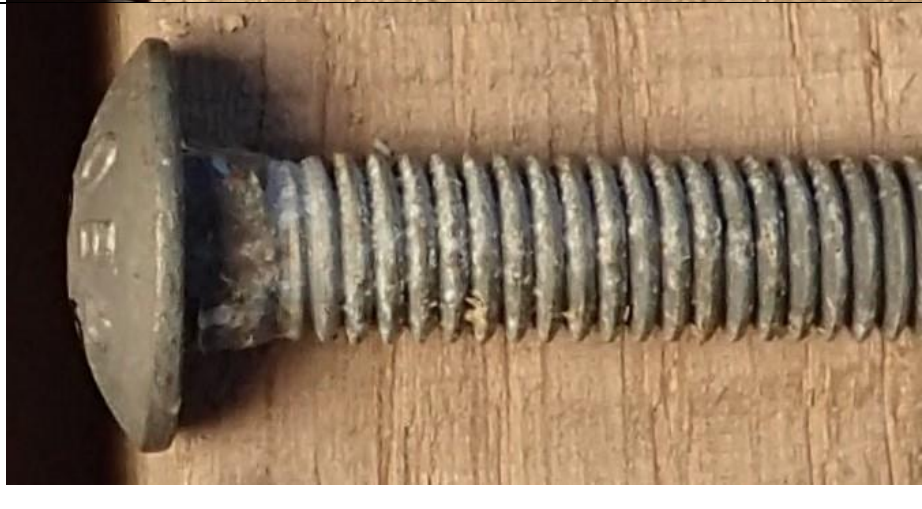
<p>The bolt on the left was imbedded in MCA lumber. It shows corrosion mostly on the crest of the thread.</p>
