Working with contractor Mike Vilegi and the DEC, in May 2019 the Friends of St. Regis Mt. Fire Tower completed a project to replace all 24 cross braces on the tower.

Restoration 2015 - 2016

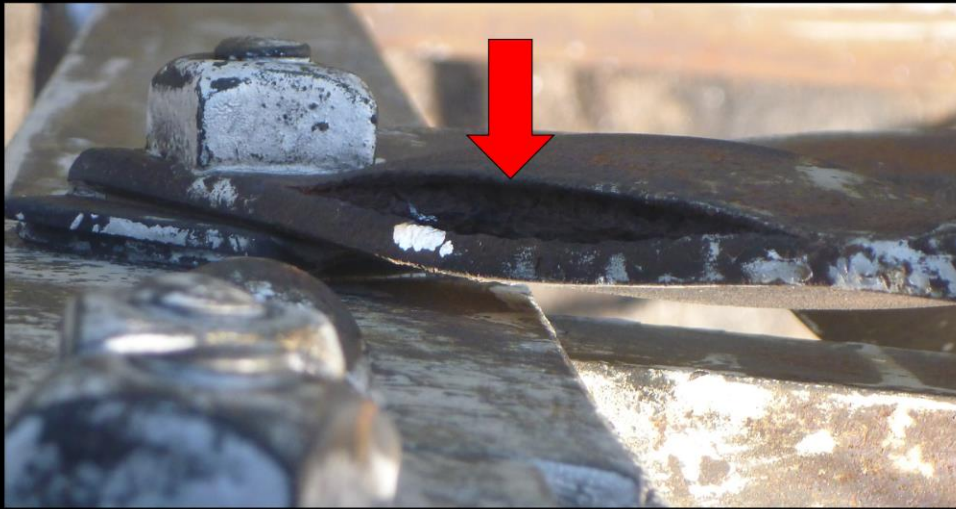
DEC Inspection Report – 2013

24 braces = 48 ends
46 ends in failure

The 2013 DEC Inspection Report identified the problem, but did not detail the extent of the issue.

The Friends originally planned to have the DEC undertake the brace replacement project, but due to issues such as bidding and sole source contracting it became apparent that it would not be a speedy process. Thus, the Friends decided to take it on. Note from this slide that the brace failure is directly related to an original manufacturing error in which the steel within the folded ends did not receive proper galvanization.

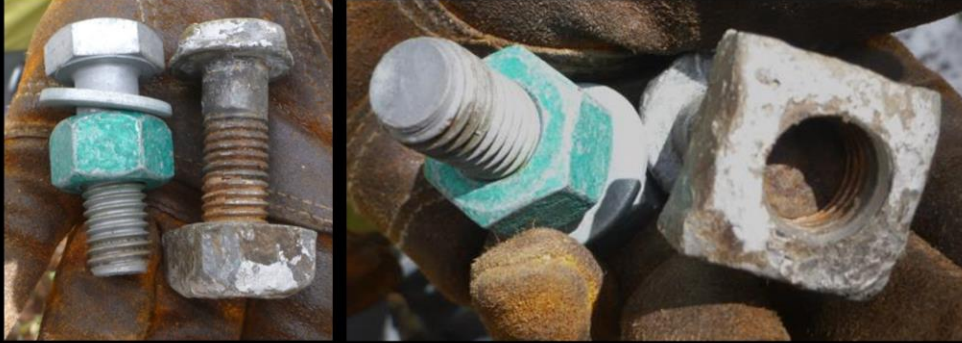
Nuts & Bolts

Hot Dipped Galvanized

A325 Structural – Engineer Recommended
Readily available - **\$110**

Grade 5 Square Head – Region Requested
Custom tapped and hot dipped - **\$1,282**

In the Inspection Report, the DEC engineer recommended using Structural bolts and nuts which are readily available.

At the 2016 FFLA conference a representative from Region 5 informed us that Grade 5 square head bolts and nuts should be used in order to duplicate the original hardware. At the same time he acknowledged that such hardware may not actually exist as a hot dipped galvanized item.

After a number of months researching the availability of square head stock we determined that the items would likely need to be custom made.

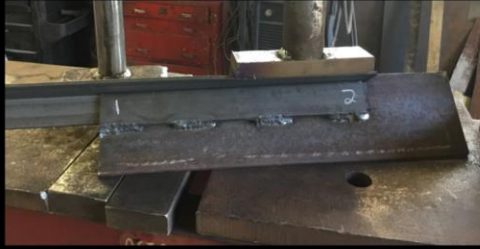
Custom Made Jig

Fabrication involved making a jig, heating and bending to a spacer which was used to maintain a gap ensuring that zinc would flow into the bend upon hot dipped galvanizing.

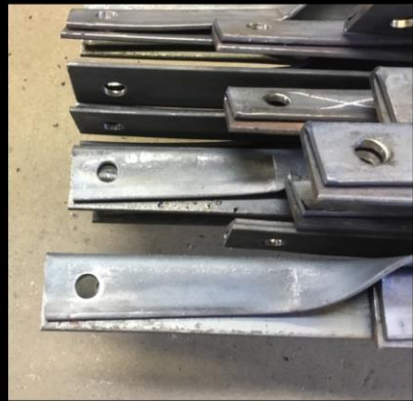
Oversize Holes

All holes drilled before galvanization need to be oversized.

The original braces were 1/8" thick angle steel. The engineer recommended using 3/16" thickness. With correct fabrication the extra thickness is probably unnecessary. The thicker folds in the new braces provided less area to drill holes and required longer bolts.

As recommended only one hole was drilled before galvanization. The other holes were drilled and cold galvanized on site. With careful measurements and original braces used as templets all holes could probably be drilled during fabrication.

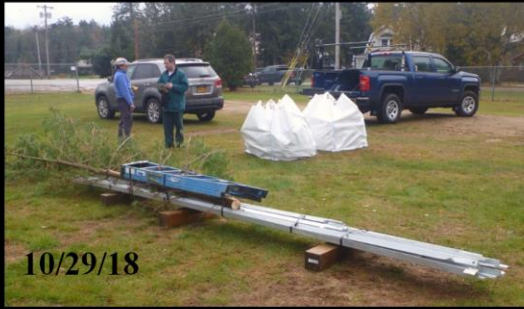
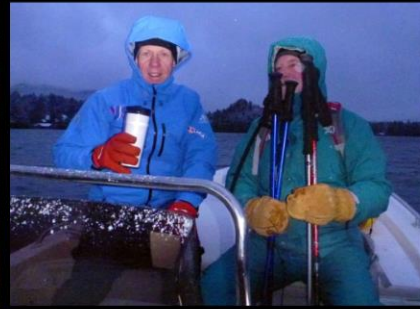
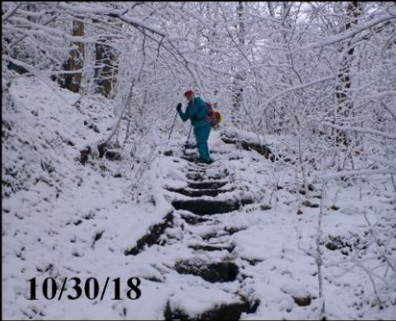
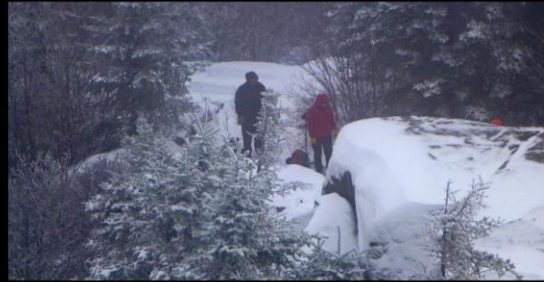
Transportation of Materials

The braces were completed and delivered to the DEC by the end of August 2018. Due to fire suppression activities earlier in 2018 there was no helicopter time available. Thus, the mission was scheduled to be part of a larger supply flight to the backcountry. The flight was to take place on October 30th, so Friends volunteers crossed the lake in the dark on a cold snowy morning to hike up and meet the load. We waited on the summit for four hours before the mission was cancelled due to weather.

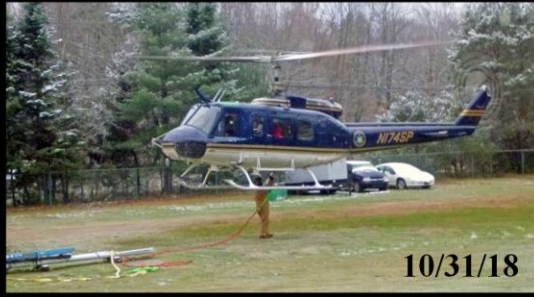
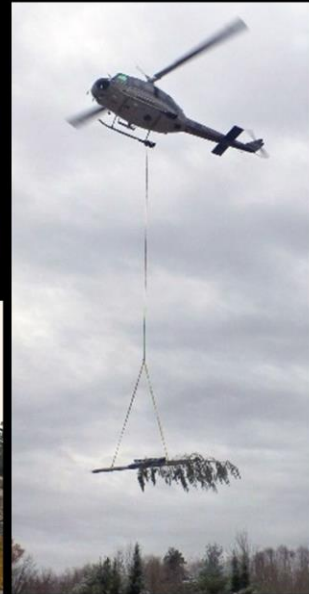
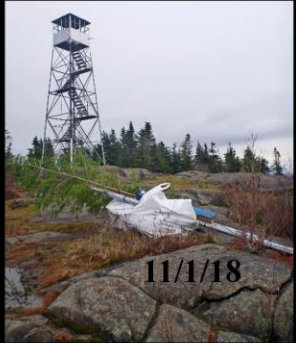
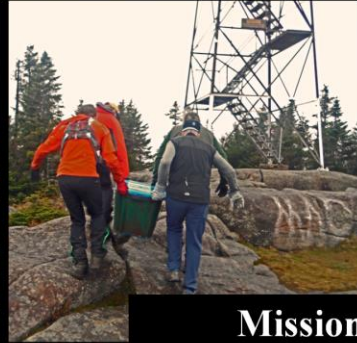
Transportation of Materials

The flight did take place on October 31st. The Friends volunteers hiked up the next day to take care of the tools, equipment and materials. Other hikers were also recruited to help.

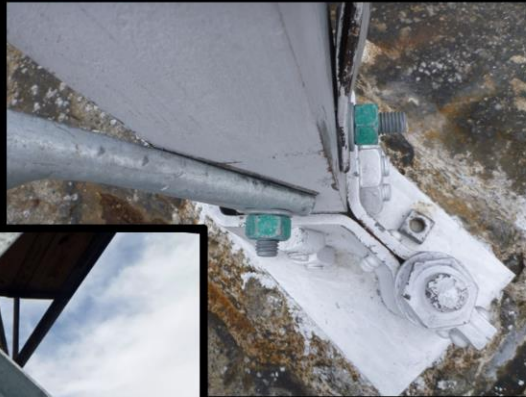
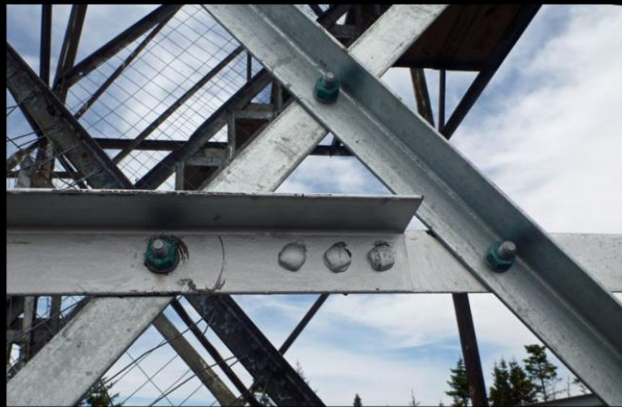
First Attempt - 11/4/18
Postponed the next day
To be resumed in May

The contractor arrived on the site a few days later, set up camp and started to install the braces. The following day winter set in and the job was postponed until spring. However we did learn that we need longer bolts. Fortunately we were using readily available Structural bolts and not custom made stock.

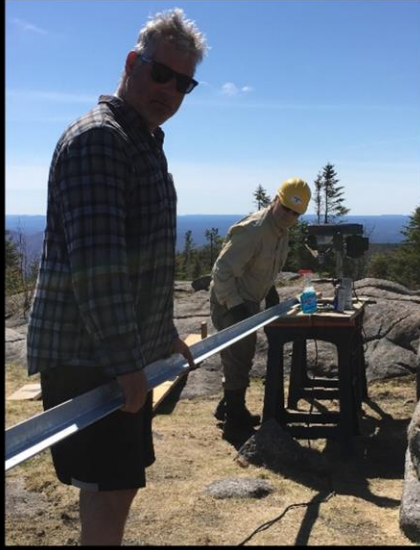
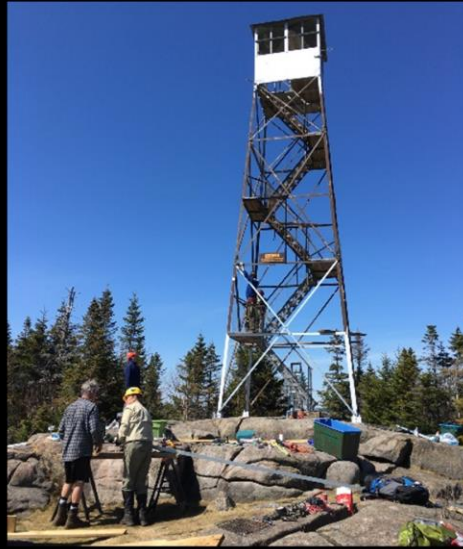
Equipment & Site Check
Sunday - 5/5

On May 5, 2019 the contractor and volunteers hiked to the summit to check on the equipment and prepare to start the project again. After 2 days of heavy rain the brace replacement resumed.

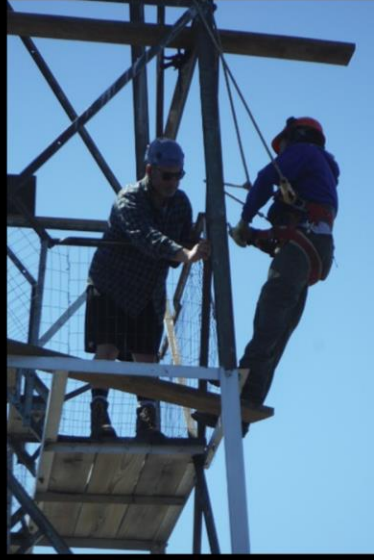
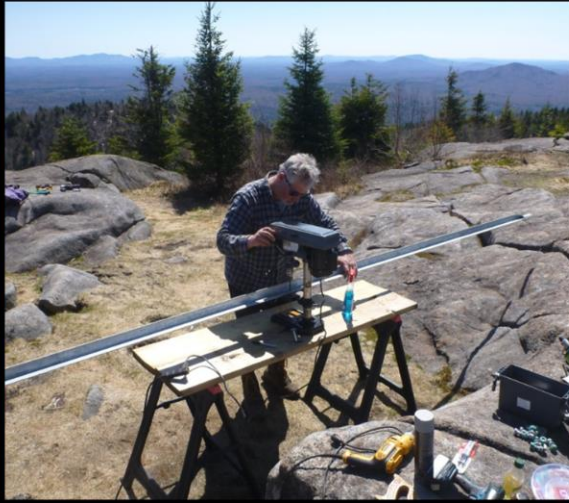
Work Continued
Saturday - 5/11

After two days of more heavy rain the work was continued and completed.

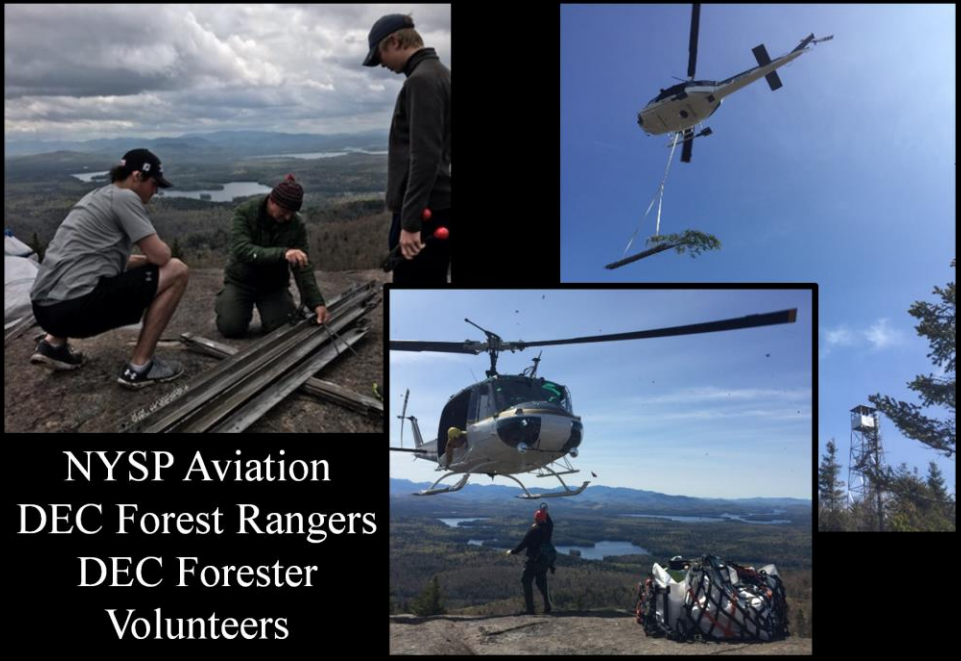
Removal of Materials

Materials and equipment were staged for removal. A local Ranger hiked to the summit to band the old braces and prepare for the flight. He recruited a group of hikers to help. After one delay the mission was accomplished. The cooperation and expertise of the State Police Aviation unit, the DEC Forest Rangers and DEC Foresters is vital to making projects like this possible.
