Fire Towers, Lumber, and Corrosion - Should We Be Concerned?

Ed Engelman, December 3, 2020
engelman.ed@gmail.com

The Rock Rift Fire Observation Tower is located on Tower Mountain above the Cannonsville Reservoir in the Town of Tompkins, Delaware County, New York. This investigation will inform decisions to be made regarding its restoration.

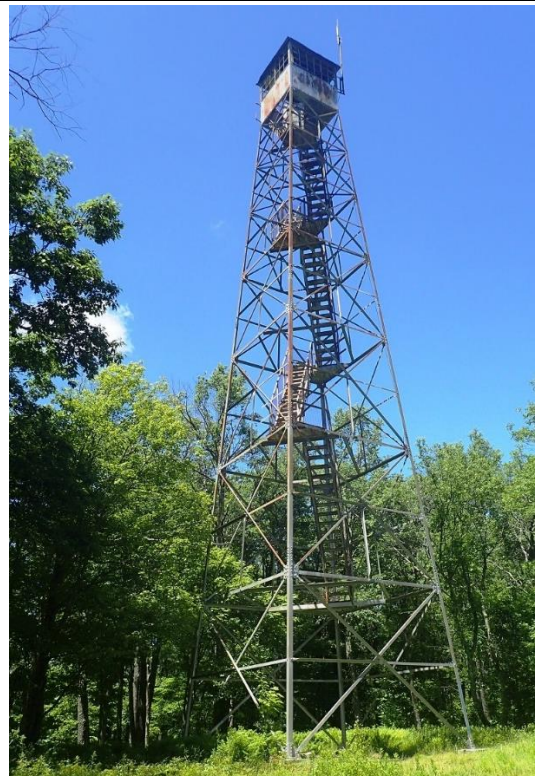
Pieces of the 100-year-old cross braces from the St. Regis Fire Tower were used in this investigation. The old braces were replaced by the Friends of St. Regis Fire Tower with newly manufactured hot dipped galvanized braces in 2018 and 2019
